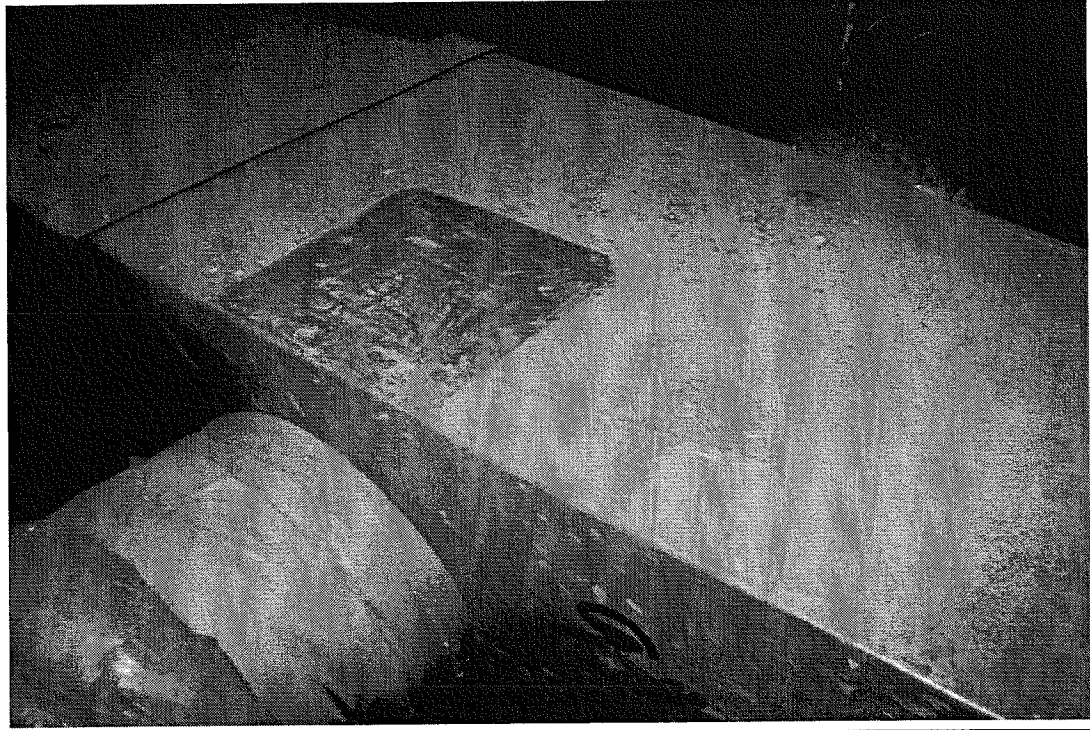
Photo 131. Location of Dust Sample # 1 and Surface Contact Sample # A-1 on top of metal HVAC duct, above suspended ceiling 10th floor, W side - hallway outside Rm 1024

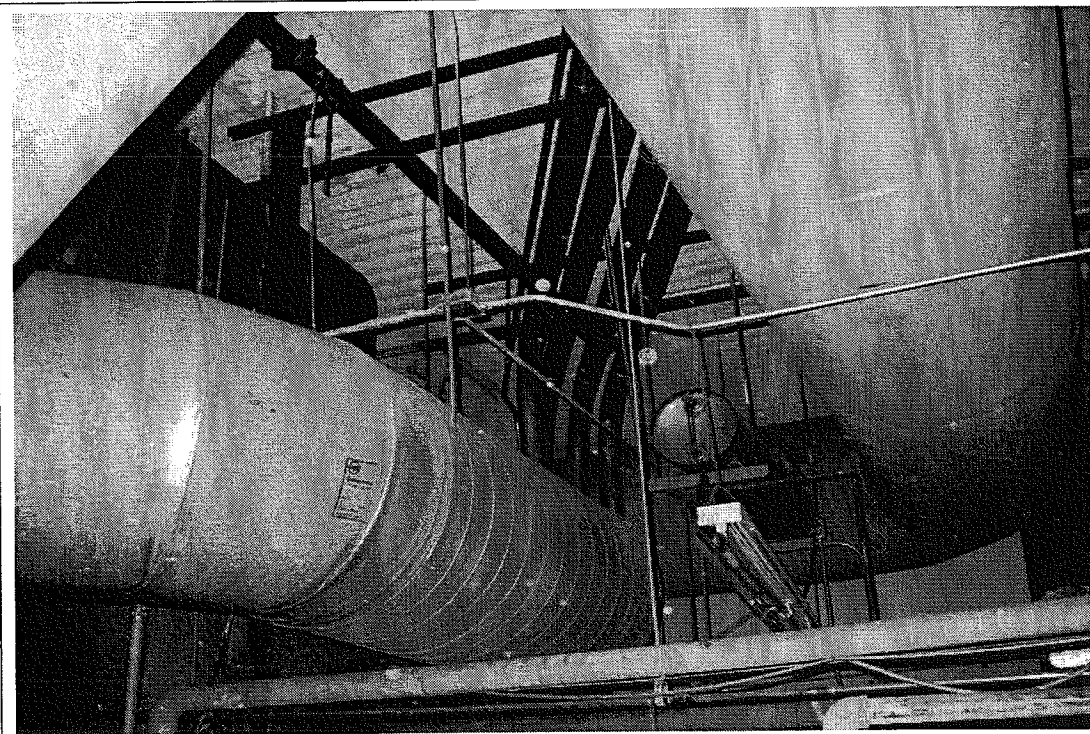
Photo 132. View of fireproofed I-beams and metal pan decking in penthouse floor mechanical room

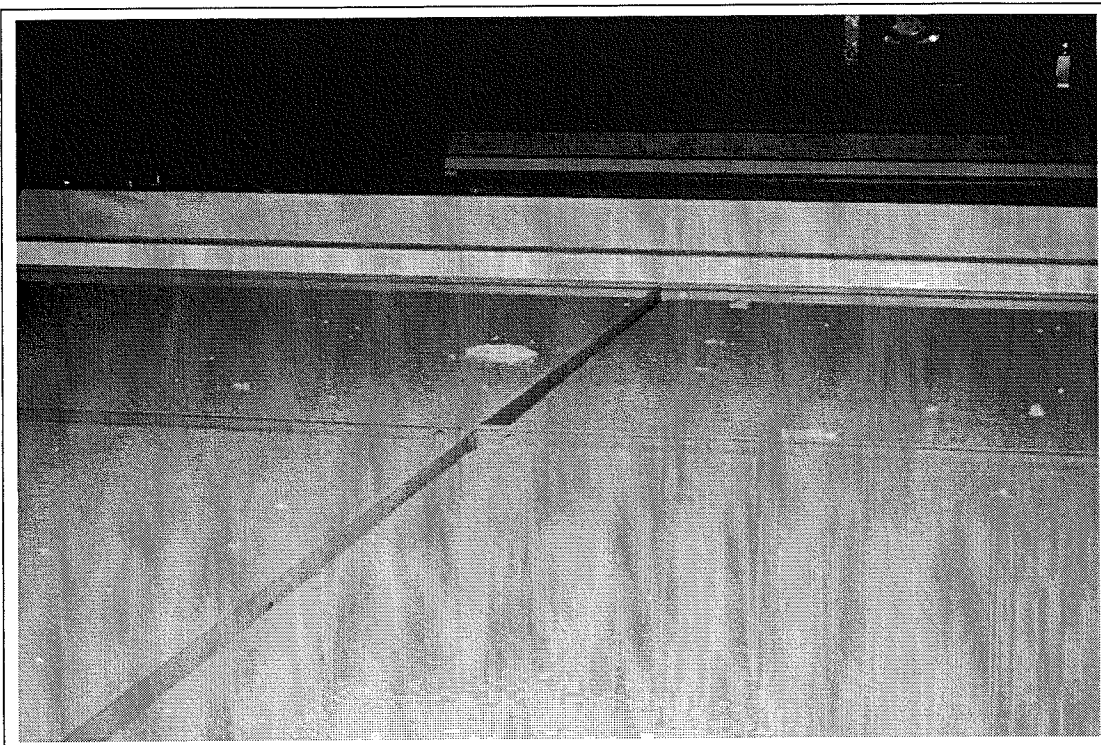
Photo 133. Dislodged fireproofing chunks on top of suspended ceiling 8th floor, east side above office cubical

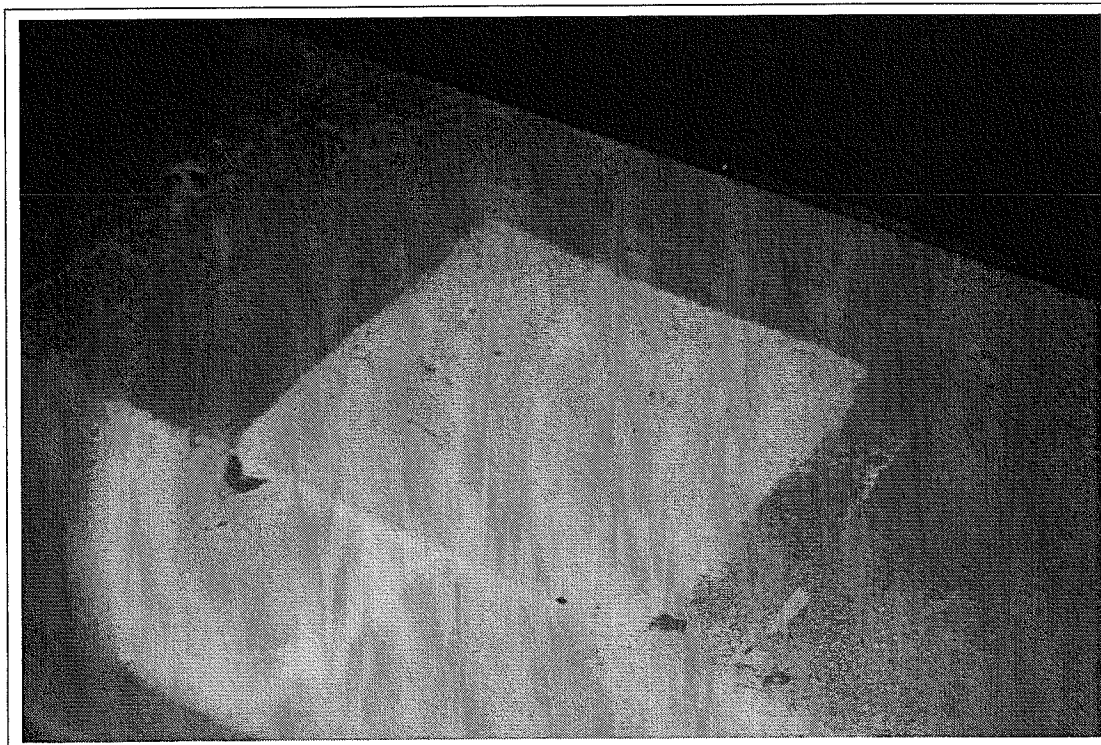
Photo 134. Location of Dust sample # 2 (top of fluorescent light fixture), above suspended ceiling 8th floor, east side above office cubical

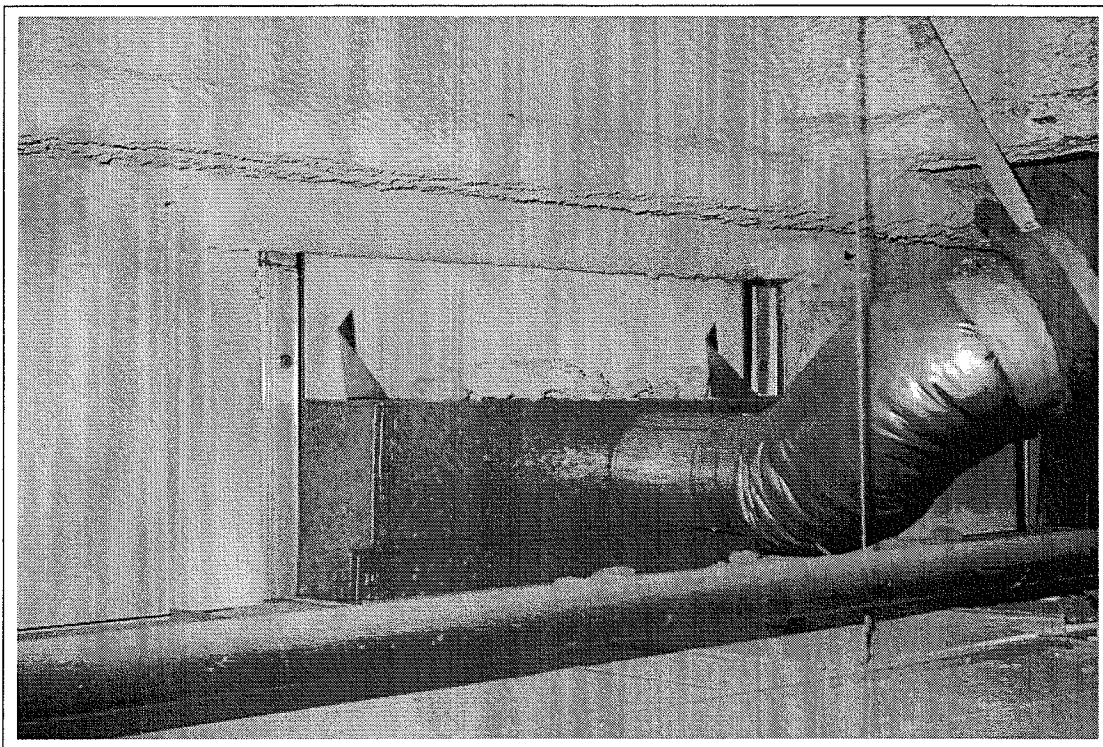
Photo 135. View of delaminated fireproofing on top of HVAC supply duct , above suspended ceiling on 8th floor, east side adjacent to elevator lobby

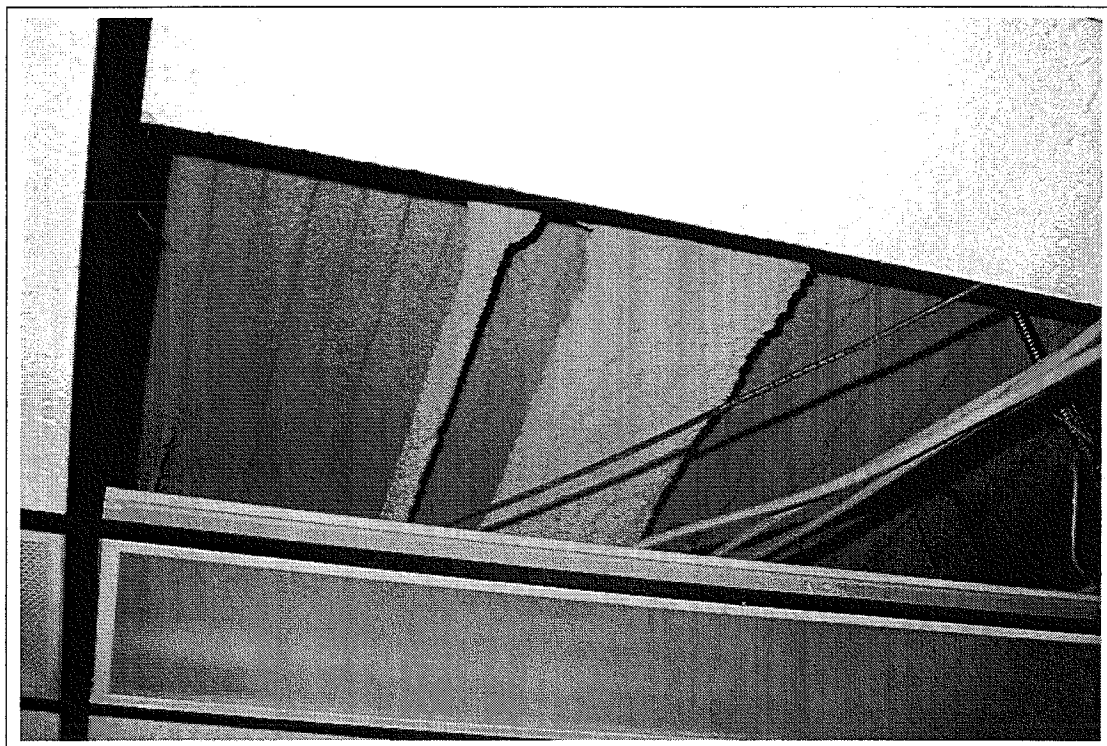
Photo 136. General view of Fireproofed I-beam, decking and piping above suspended ceiling 6th floor, W side – at copier/mail area near front of office

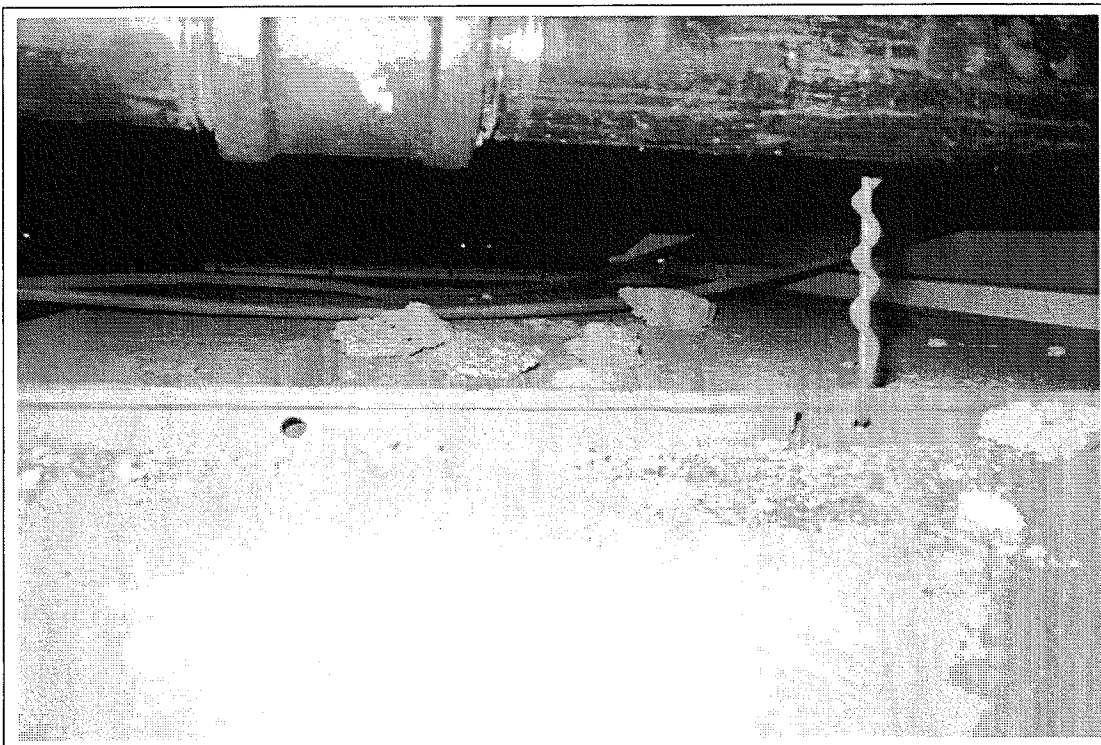
Photo 137. View of dislodged fireproofing debris on top of suspended ceiling 6th floor, W side – at copier/mail area near front of office

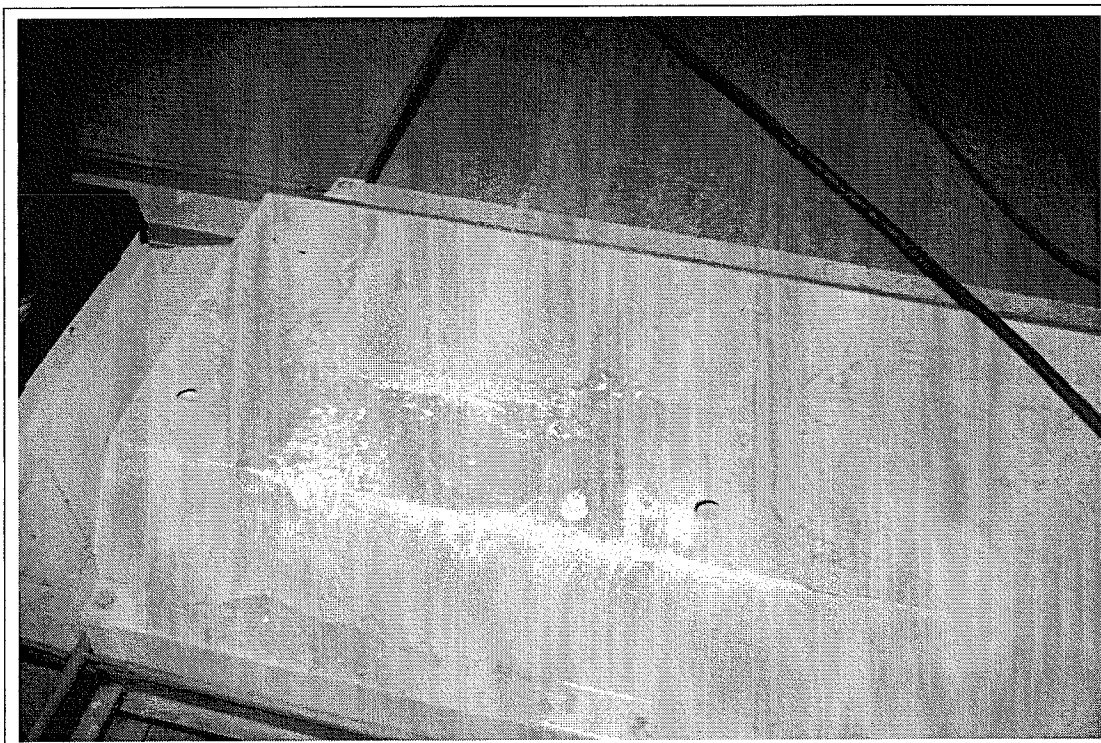
Photo 138. Location of Dust Sample # 3 and Surface Contact Sample # B-3 (top of fluorescent light fixture), above suspended ceiling 6th floor, W side – at copier/mail area near front of office

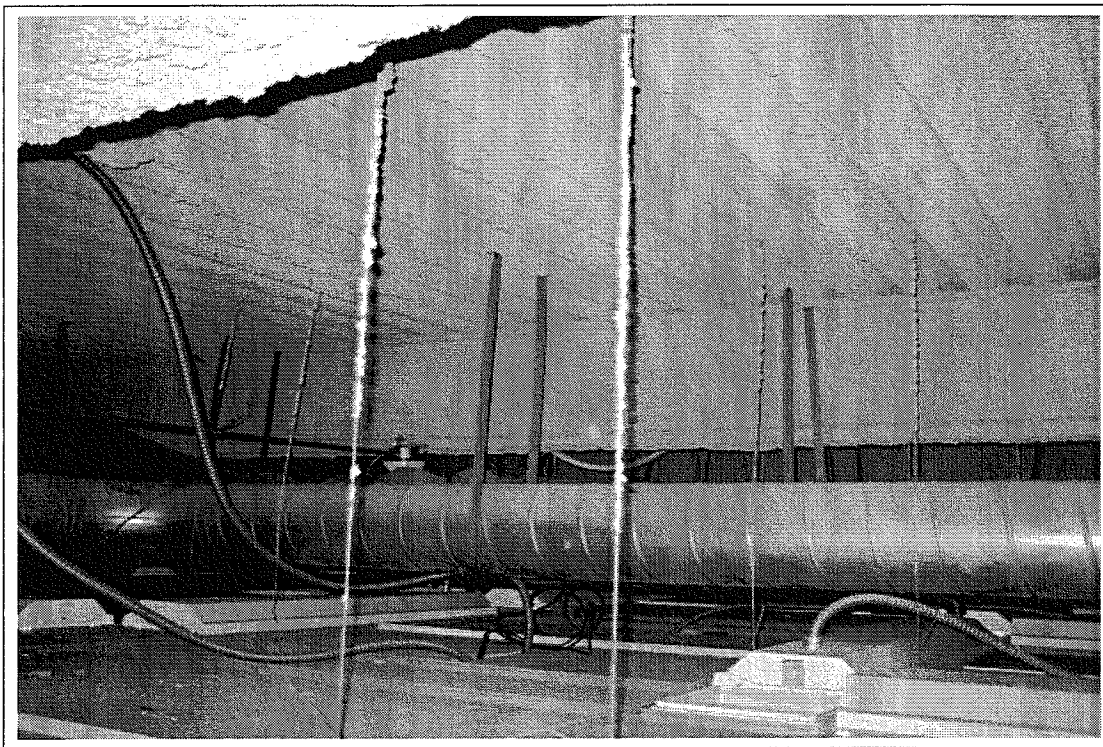
Photo 139. General view of fireproofing applied to corrugated deck and beams (note: dislodged fireproofing debris on top of suspended ceiling) 4th floor, E side - above file area

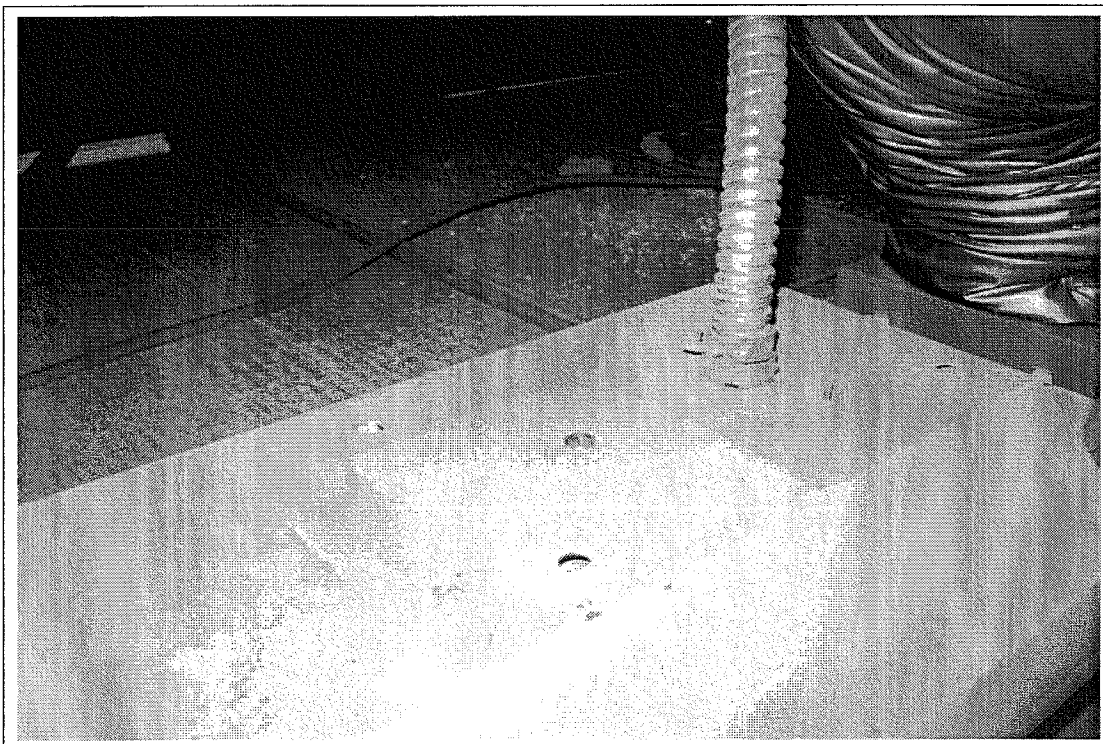
Photo 140. Location of Dust Sample # 4 (top of fluorescent light fixture), above suspended ceiling 4th floor, E side - above file area
